START UP TIMES FOR VP RECEIVERS

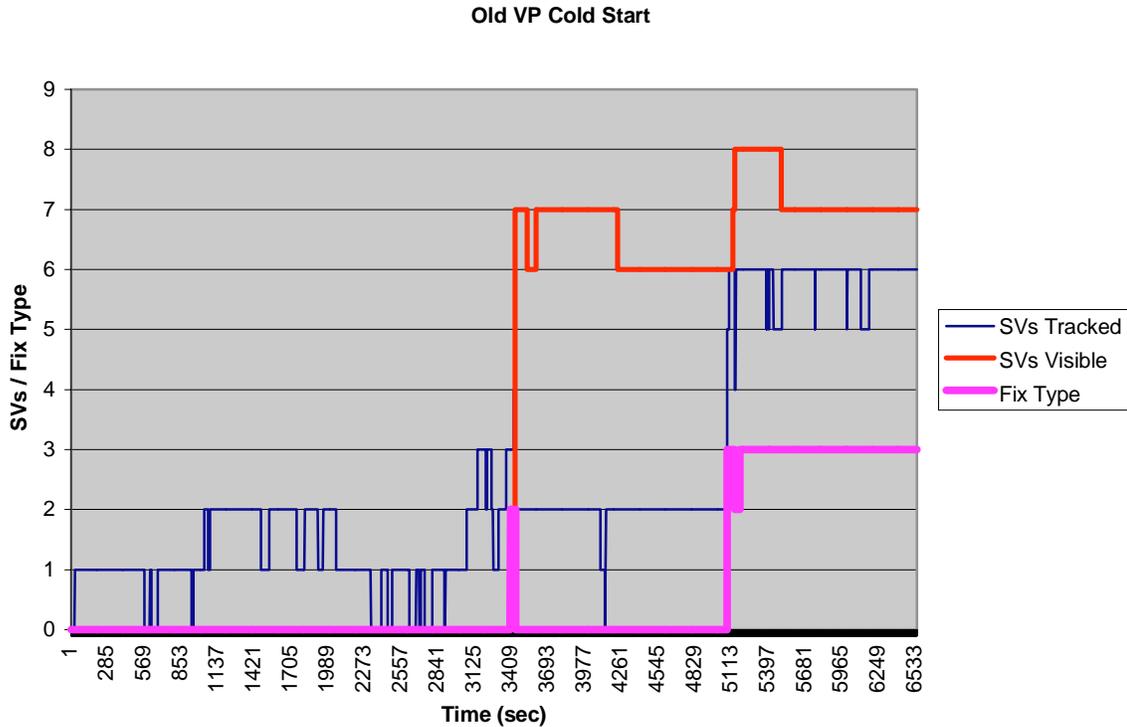
This is best illustrated with the following graph. This graph shows the start-up progression of an old 6 channel VP that has been sitting in a box since 1995. The receiver was initialized using our SynTAC control program, which initialized the receiver and loaded in correct time and position at time "0". Note that the receiver variously tracks 0, 1, 2, or 3 SVs for approximately 5000 seconds (over an hour and twenty minutes!) without ever acquiring a fix. We do get three SVs a couple of times at around the 3300 second mark, but the Dilution of Precision (DOP) never gets low enough for the receiver to declare a valid 2D fix.

Note also that the "SVs Visible" trace goes from 0 to 7 at about the 3400 second mark, indicating that a valid almanac has been successfully downloaded. Well, you say, this simply cannot be. It only takes 15 minutes or so to download an almanac. Well, yes, and no. What the graph does not show is that during the time that the receiver was trying to download the almanac, satellites were being acquired and lost with great regularity. Maybe a page of the almanac got through here or there, but it took almost an hour for the entire almanac to be successfully transferred.

Things get even stranger when we look at the period between 3400 and 5000 seconds. Here we have a receiver with time, position, AND a valid almanac, and it still takes almost another half

hour before it starts tracking satellites properly and delivers a valid 3D fix. Note that at the 5000 second mark the number of tracked SVs jumps from 2, to 5, to 6, in a matter of a few seconds. Guess what? The receiver has finally discovered the magic combination of oscillator parameters.

At this point the receiver can be considered “cured”, and will operate in a more normal manner. Even so, I usually let the receiver remain powered up for at least another half hour to allow the new oscillator characteristics to be transferred to EEPROM. This is accomplished as a background task by the microprocessor, and as such can take some time. If you disconnect power before this task is complete, you might just get to go through the whole process over again.

That’s about it. Bear in mind that your receiver does not need to be five years old in order for this problem to occur. It all depends upon the oscillator aging characteristics of the specific receiver. This could conceivably happen to a brand new B8 that has been sitting in your stock room for as little as six months. Just don’t give up on it too soon. Once things have been recalibrated the start-up times will return to normal.
